Replacing rear wing window regulator R170

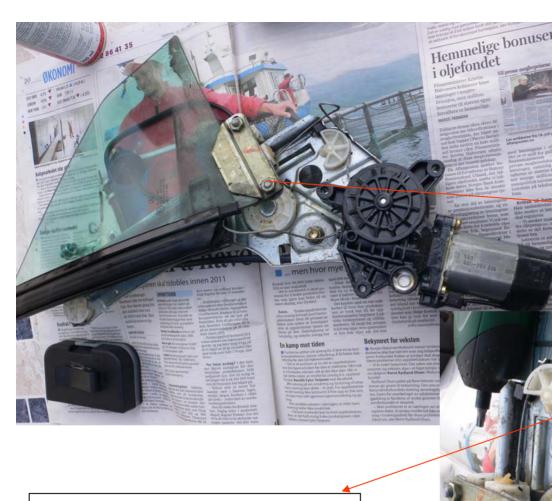
Old window assembly out. Note That the wire is off and kinked beyond repair. Motor removed on Picture below.

Wire damaged by motor after wire came off guide and roof was operated.

New Window regulator needed from dealership.

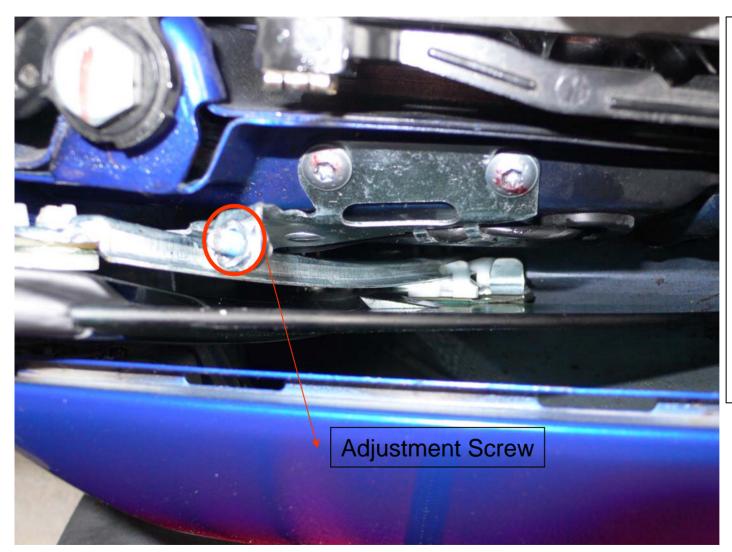
New window in place.

Run electric Cable through Bulkhead before Sliding in window.

Redo upper two
Torx bolt and
lower nut.
Reconnect electric
Cable on inside.
Replace rubber
Seals and PVC
Panel.

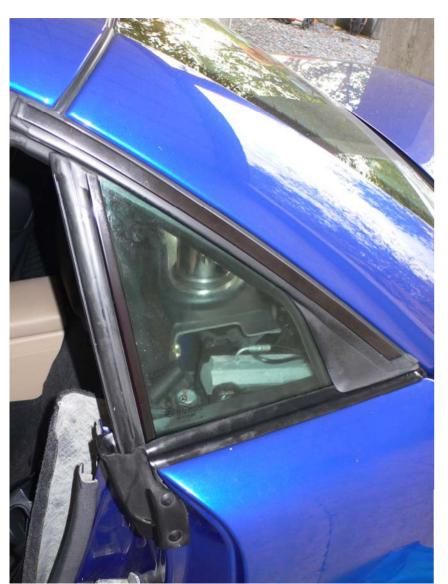
Test of new window

I got away with minimum adjustments, Probably because I refitted window as close as possible to the settings on the old window mechanism.

Do a test run of the new window assembly. Note angle and position of window relative To upper rubber seals when window is up.
