# FACTORY SERVICE BULLETINS

## Steering - Squeaking Noise Turning Steering Wheel

Order No.: P-B-46.10/19

Squeaking Noises When Slowly Turning The [Steering Wheel](#) and Engine is At Operating Temperature

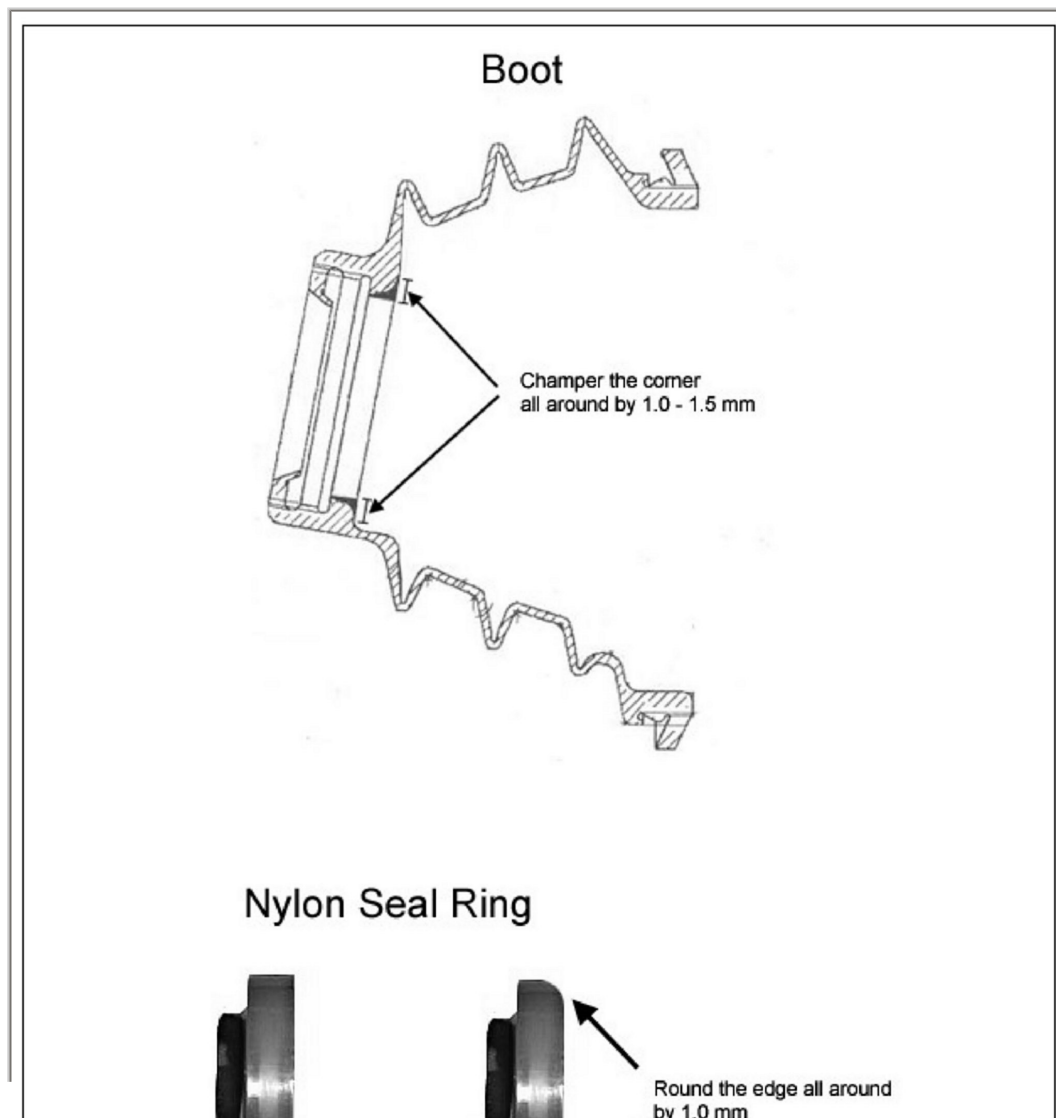
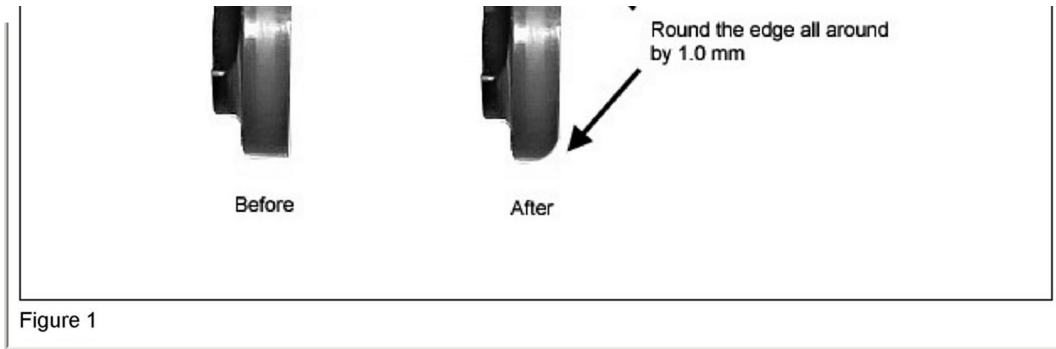
If you receive customer reports in the above model vehicles of squeaking noises while slowly turning the [steering wheel](#) when engine is running at operating temperatures, locate the source of the noise. If the noise is coming from the sealing boot between the firewall and [steering shaft](#), the boot and the seal ring must be modified (Figure 1). Lubricate and re-install the modified boot and seal ring.

**Note:** Existing boot and the seal ring can be modified. After modifying these parts per Figure 1, lubricate the existing modified boot with grease part number A001 989 84 51 10 on both sealing surfaces of the boot (inside and outside the front bulkhead).
