Head Gasket Replacement on the M104 Engine

by Steve Brotherton
First Published in: [ImportCar](#)[∞]

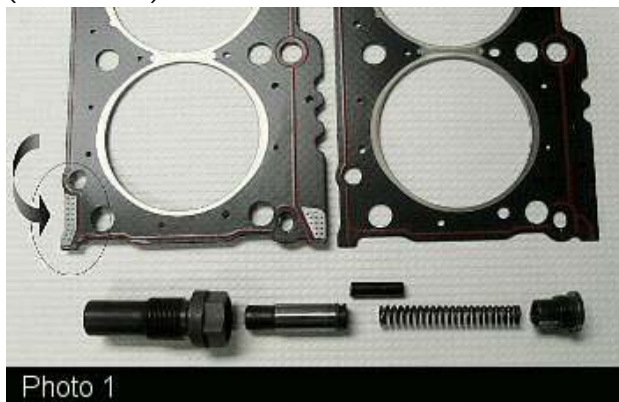
The job of sealing the two covers is efficiently accomplished with this seal when done properly. The problem arises in sealing the ends of the "U" against the rear surface. That surface is the area where the head, head gasket and block come together. If it were just against a smooth surface, it would be easy. Instead, it's located in this rough area of convergence. Based on the way that Mercedes has reinforced the newer head gaskets right behind this area (see Photo 1).

It's my diagnosis that part of the long-range problem is that the head gasket recedes under the head after a period of time. Over time, the resilience of that spongy gasket can't keep up with the receding gasket and a leak is formed.

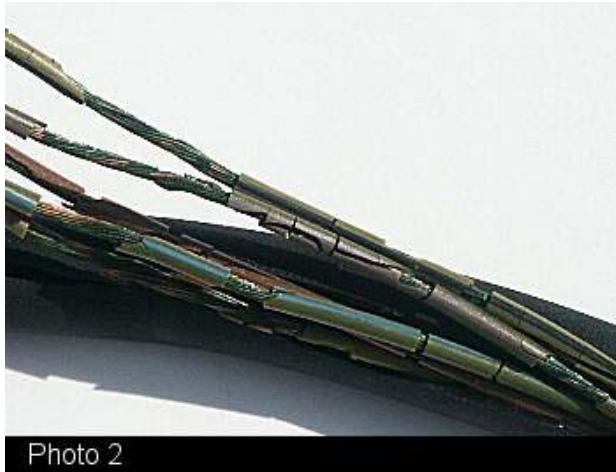
Photo 2

There are a number of risks to this job that are not technical in nature. The first, and maybe most important, deals with the original diagnostics and the sale of the job. Unlike the motor pictured during the disassembly, most of the ones being fixed are likely to be 1993-'95 HFM-injected models. These years have a significant problem with the wiring harness insulation falling apart (see Photo 2).

The act of doing this work will ruin a harness that is falling apart. It's very expensive, and something you won't need at the end of the job. The harness problems occur on the engine harness on the engine, the engine harness on the body and the harness from the throttle actuator. Be sure to check the state of these harnesses before selling this job on 1993-'95 models.

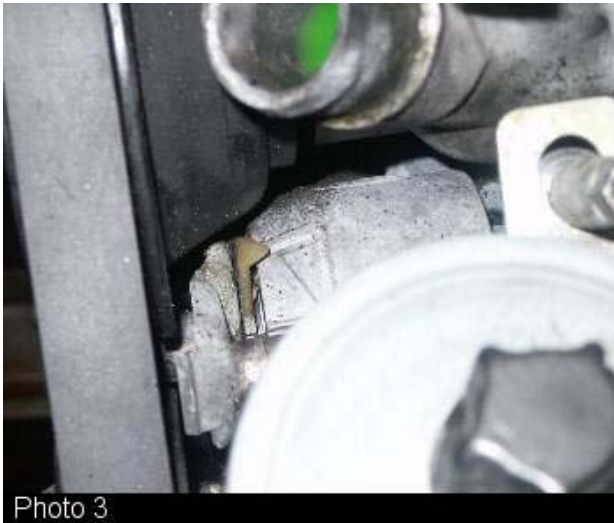
Another job risk on M-B models through 1995 involves the belt tensioner. A close evaluation or warning of risk involving the serpentine belt tensioner and water pump should be involved with estimating the job. The belt tensioner is rather pricey and always seems to fail upon reassembly. The belt tensioner is a rubber hub design, sort of like a big suspension bushing. Tension is applied by the mechanical adjuster to the inner hub. The rubber is stretched as the roller attached to the outer hub is pulled against the belt. A proper rubber hub will transmit the proper tension when the arrow is pulled to the mark as seen in Photo 3.

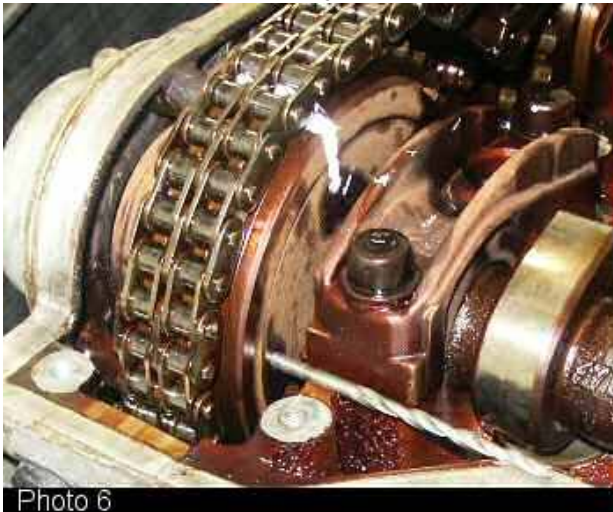
The upper timing cover is easily removed. It is a good idea to make yourself familiar with the timing marks and their orientation at this point. As you'll see in Photo 6,

we've made a mark across the chain and gear. This is a cross-check for use in final assembly of the intake cam timing adjuster. The proper location of the cam is indicated by a 4mm drift ({any 4mm rod can be used} see the drill in photo 6). In the proper position, the drift fits into the hole in the flange and sits on the parting surface of the head. The same arrangement exists on the exhaust side.

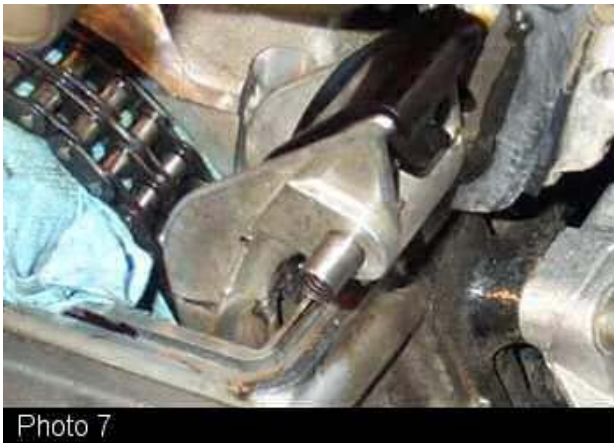
Photo 7

After becoming acquainted with the cam timing arrangement, remove the exhaust gear. Probably one of the toughest issues can be the removal of the pin from the driver's side guide rail (see Photo 7).

This pin is often difficult and must be removed to get the head off. We use a small slide hammer of our own manufacture. The center of the pin is threaded, and it can be pulled with a bolt and various cylindrical spacers such as the socket in Photo 8.

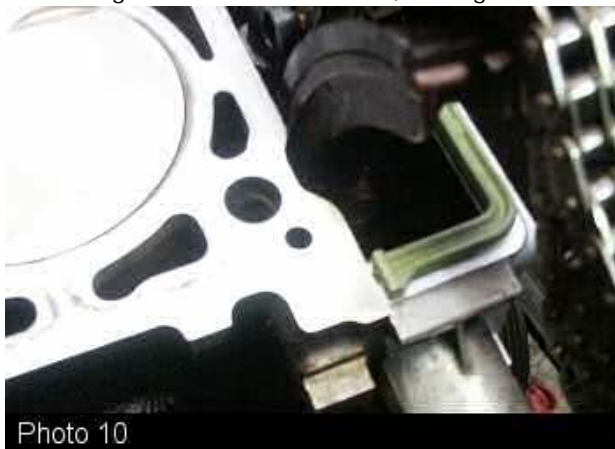
The process of sealing also has been covered in updated information from Mercedes. There are two recommended sealants: The first, M-B p/n 002 989 47 20 10, is used sparingly on the vertical metal-to-metal surfaces. At the point of convergence between the head, head gasket and the cover seal (see Photo 10 with the head removed),

a dab of M-B p/n 001 989 61 20 10 should be placed before assembly. There are other similar sealants that make a sticky flexible seal, but the M-B variety works well. No sealant should be used on the "U" seal (except where the dab sits at the ends of the "U").

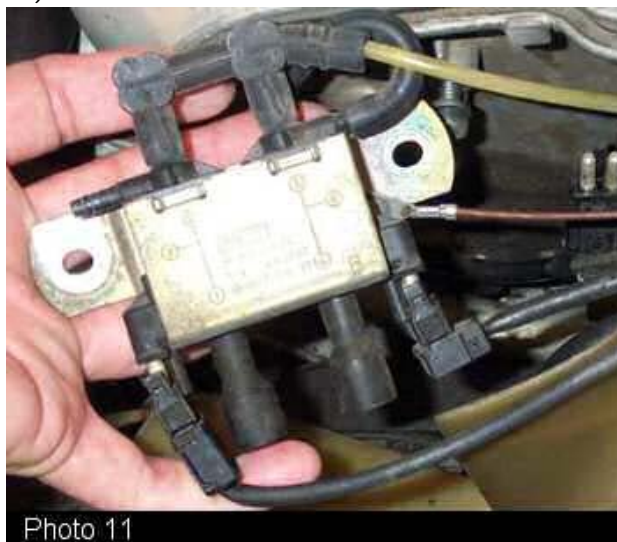
So, the rest is a piece of cake. The remaining pitfalls are usually a "check engine" light after a five-mile drive. It seems that quite often the vacuum lines to the switchover valve at the front of the motor get switched (see Photo 11).

These are for control of the EGR and Secondary Air Injection, and reversal is first noticed with an EGR code. Speaking of the EGR, as mentioned earlier, we usually disconnect the EGR pipe at the valve and leave it when the head is removed. The other end of the pipe goes into the lower manifold, and one of the most common EGR flow codes is caused by a build-up of dried, burned, oily PCV vapors that cake onto the hot pipe. While the head is off, the pipe flange is very accessible. I would recommend pulling the steel pipe from the manifold and cleaning this port.
