Mercedes W210 Foglight Harness

The purpose of this document is to illustrate the steps required to renew the foglight harness. This particular foglight is from a 2001 E430.

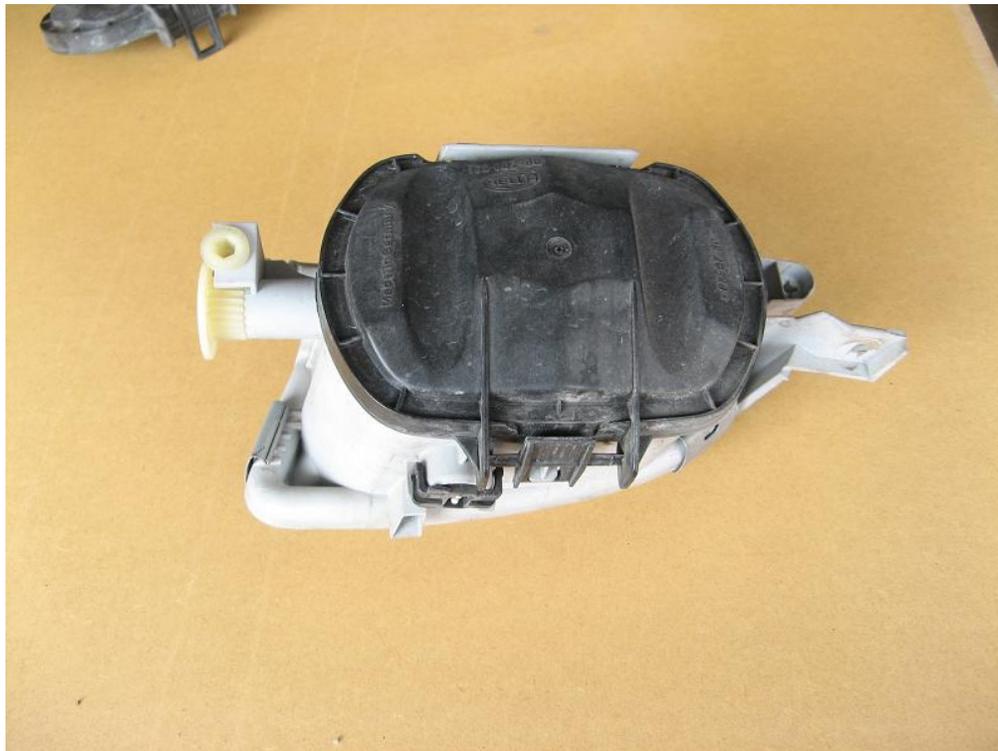
The back of the foglight.

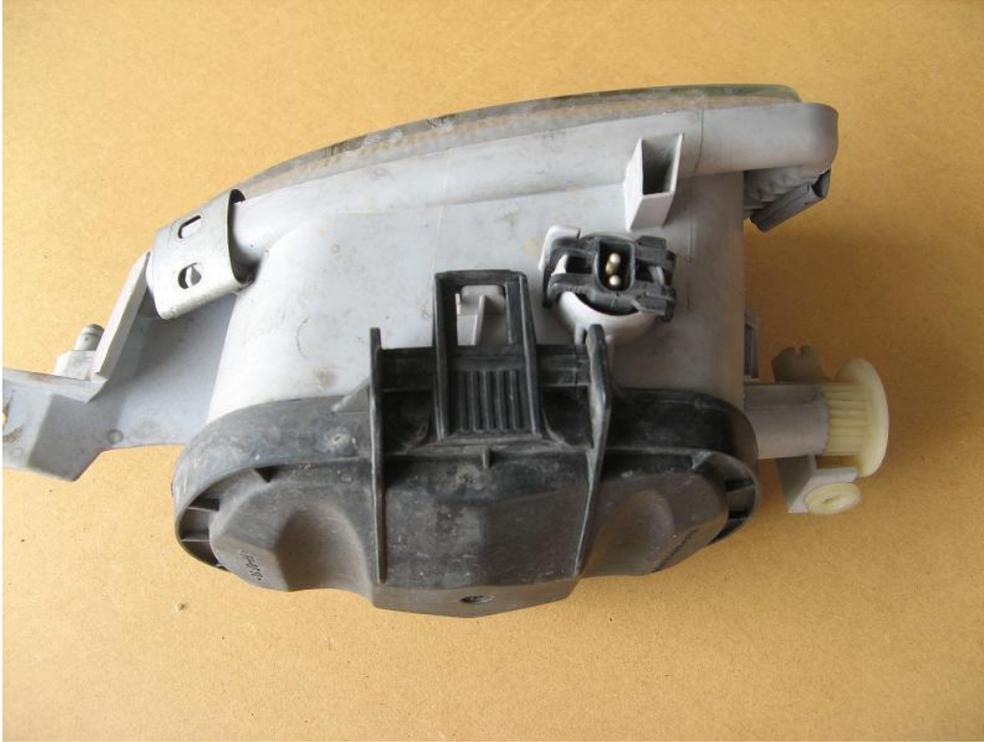
The Bottom of the foglight, showing the connector for the lamp harness.

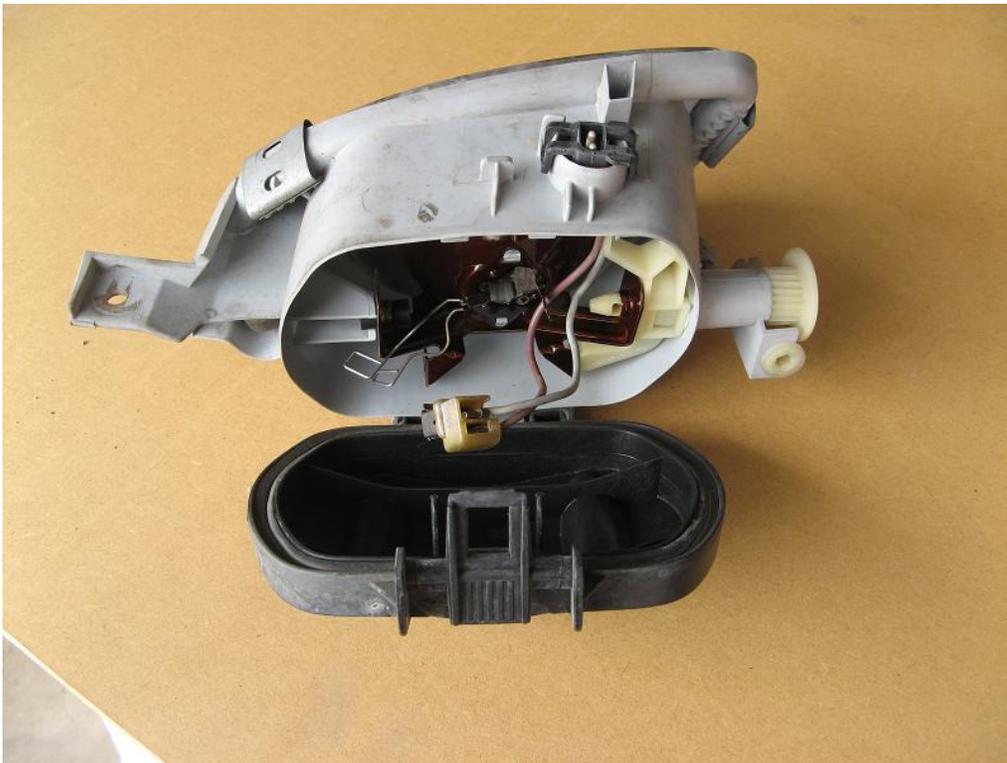
Access door opened -- the bulb for this light broke off at its base when I tried to remove it from the connector. The connector was melted to the bulb (see below).

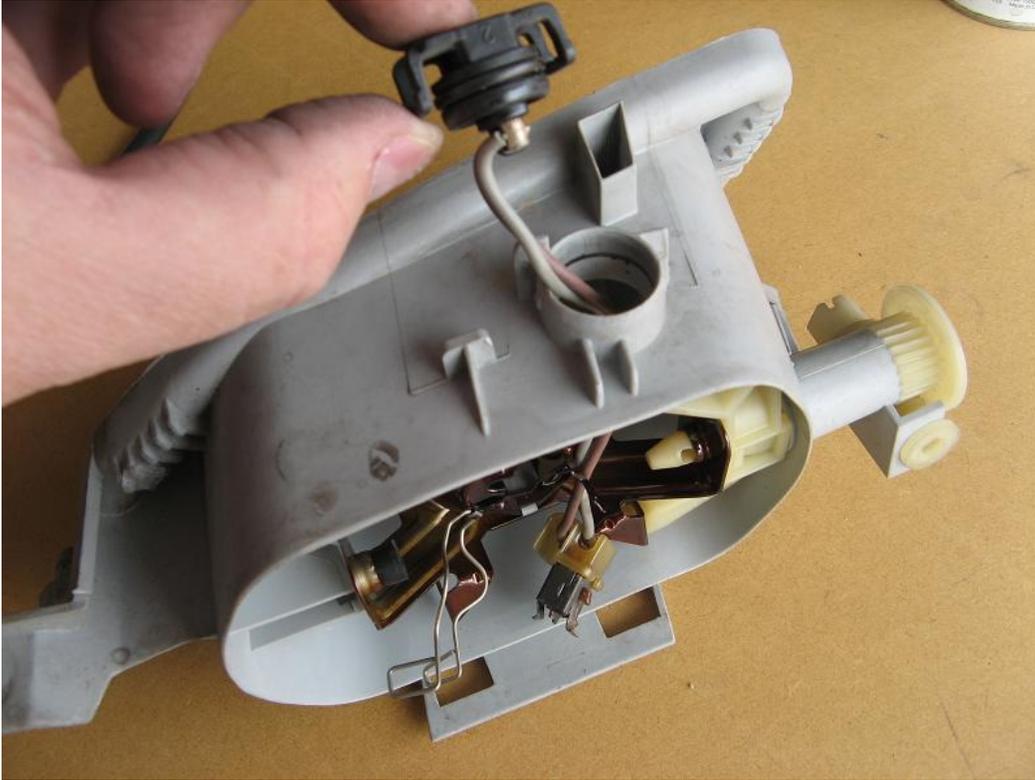
Removing the wiring from the housing

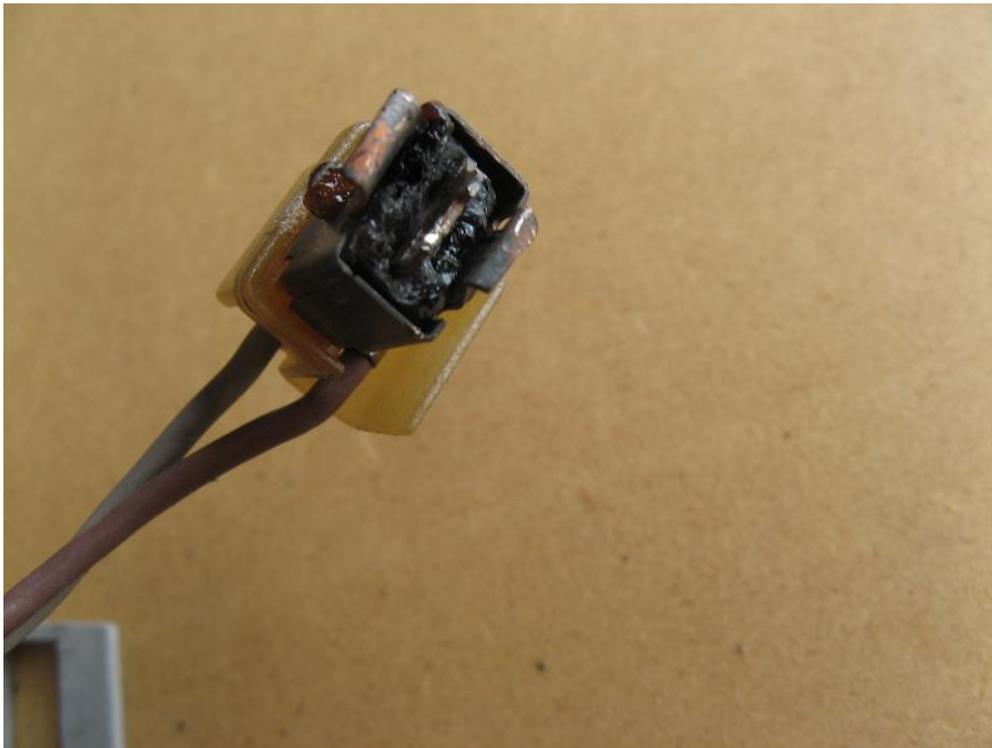
This photo shows how badly the connector was melted to its plastic shield.

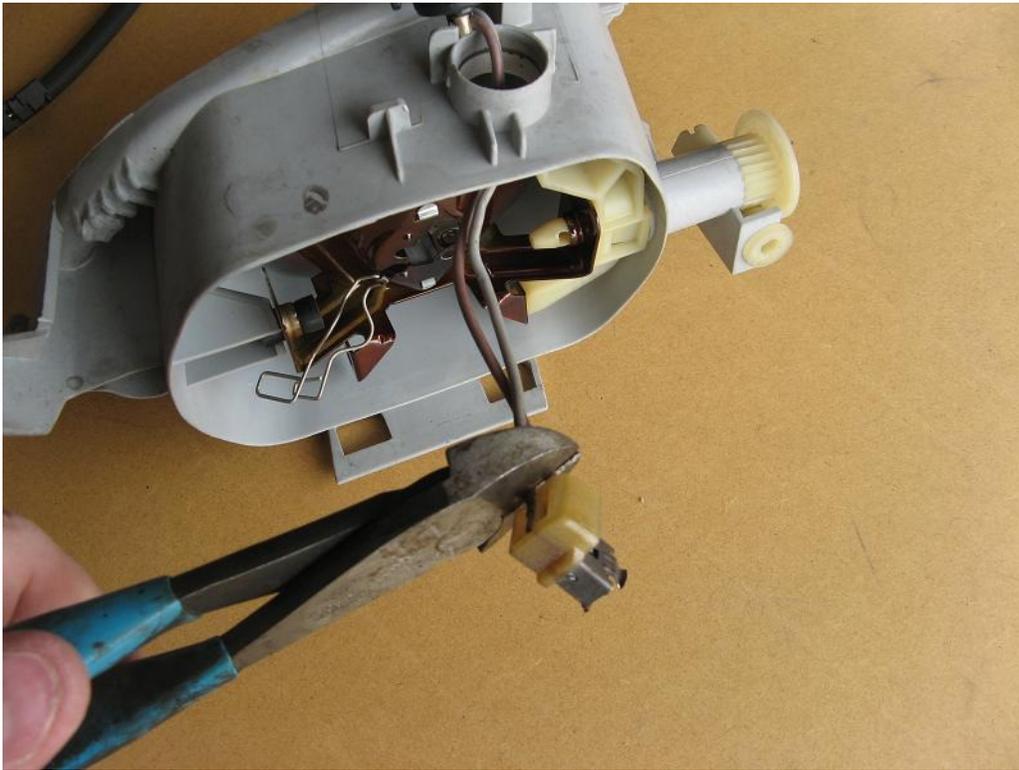
Note that the connector inside the housing is too big to fit through the opening, so I just cut it off.

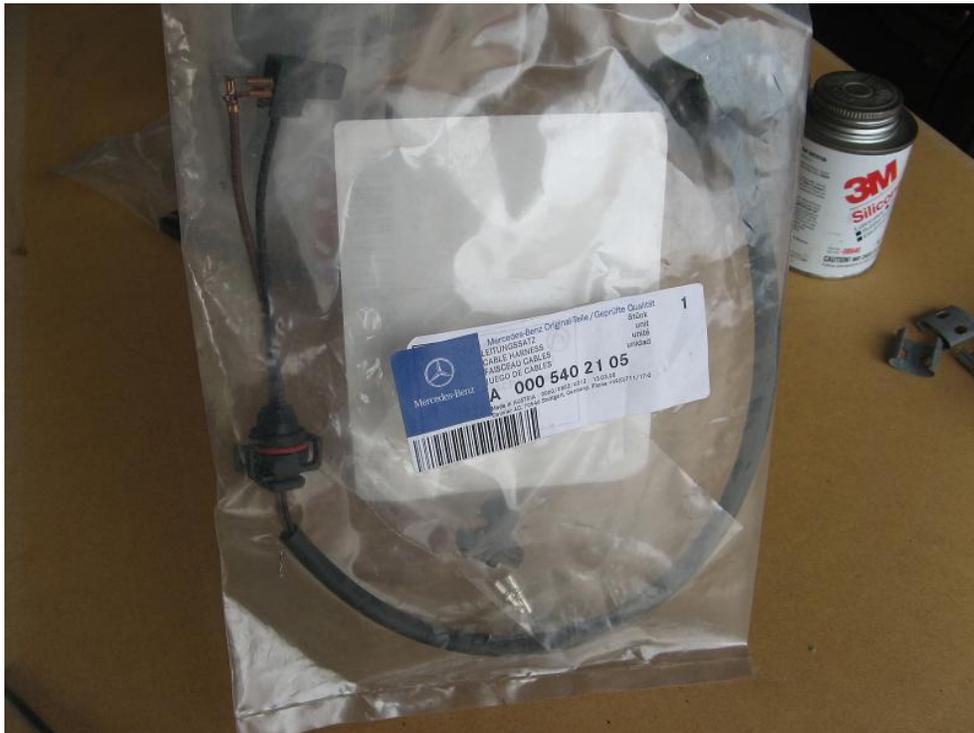
This is the repair harness. Note that it comes with a replacement pin bushing and pins. This would be handy if your existing harness were rotten where it connected to the foglight.

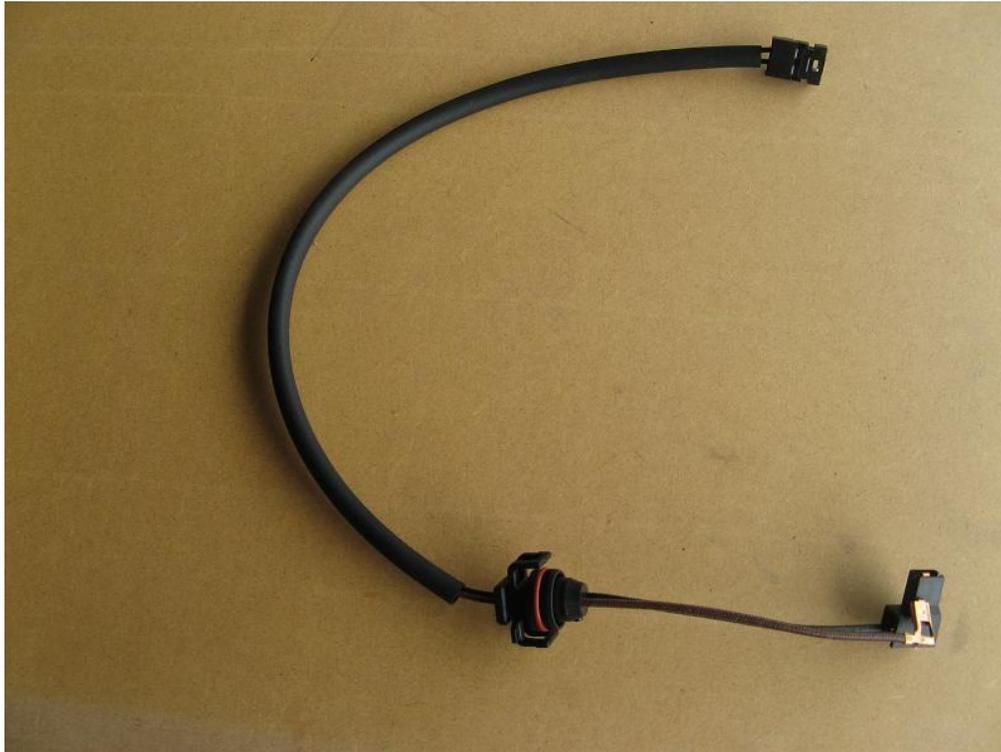
This is the harness itself. At the top of the picture is the two-pole, female connector, which snaps into your existing harness. At the bottom center is the 'grommet' which snaps into the foglight housing. At bottom right, the shielded (+) and unshielded (-) connectors for the bulb.

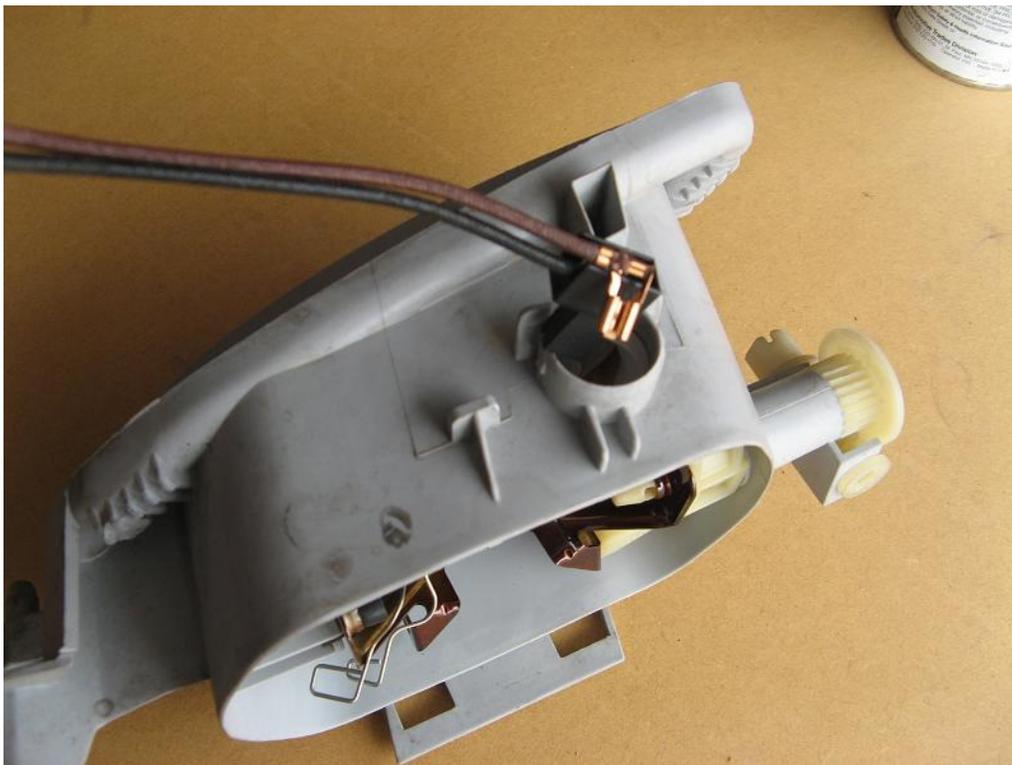
Feeding the new harness into the foglight housing.

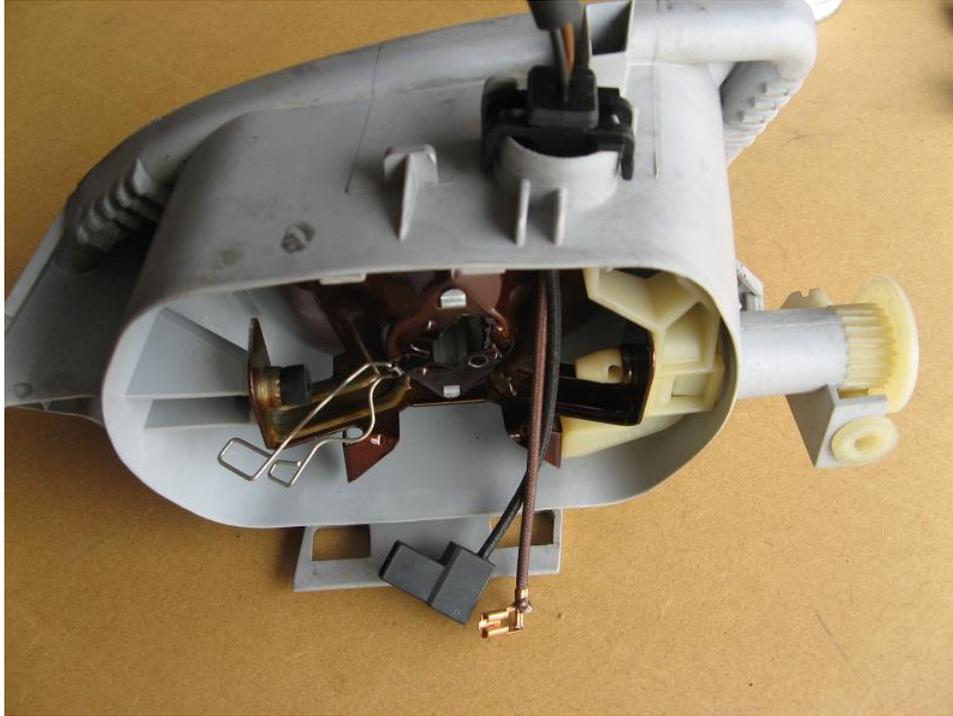
And, snapping the grommet into the housing. This grommet seemed to want to snap one way and not the other. What I noticed about this is that when it snapped in correctly, the connectors on the wires were lined up perfectly with the bulb.

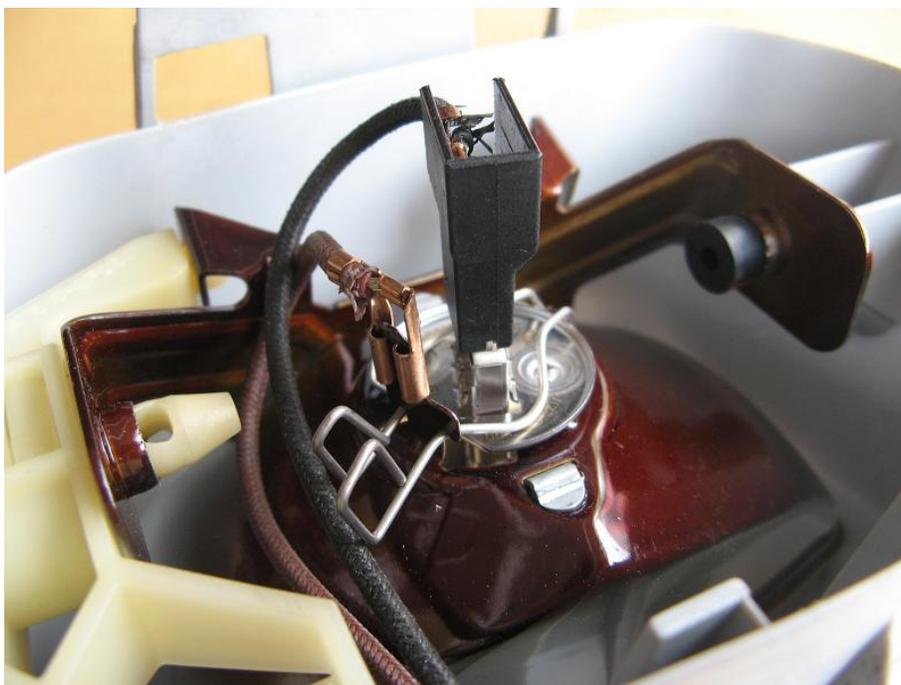
Note that the reflector is actually coated steel. The negative terminal (brown), simply connects to a spade connector built into the reflector housing, just above the bulb spring. The positive connects to the single spade terminal from the bulb.

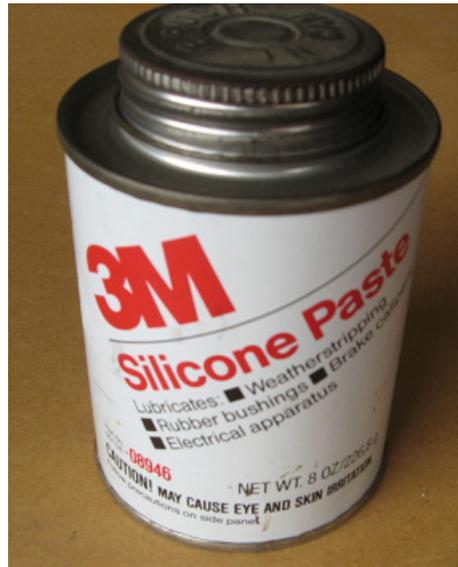
It was mentioned in the foglight glass replacement sticky, that anytime you have the foglights out is a good time for gasket maintenance. I like to use this stuff on both gaskets, it really helps them stay soft and pliable.
