Replacing rear wing window regulator R170

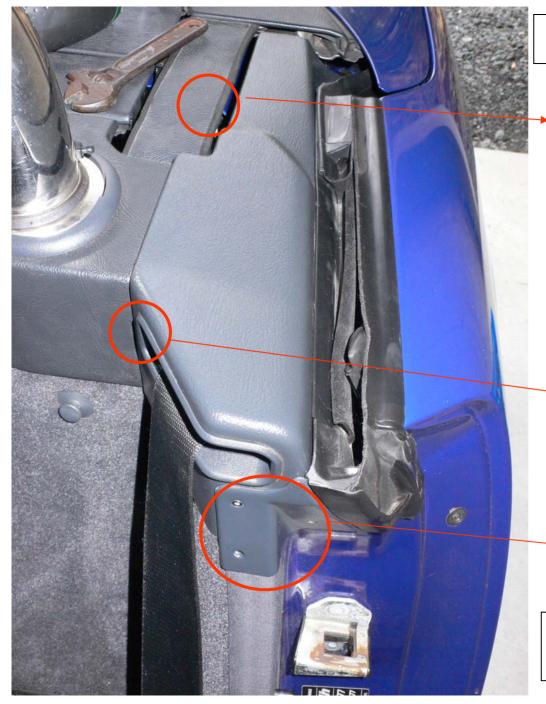
Removal of upper Cover

One #8 bolt here, under the belt.

One screw on the inside (phillips)

Three screws to loose this panel (mini torx 8)

Cover can no be slided along the safety belt, out of the way 3

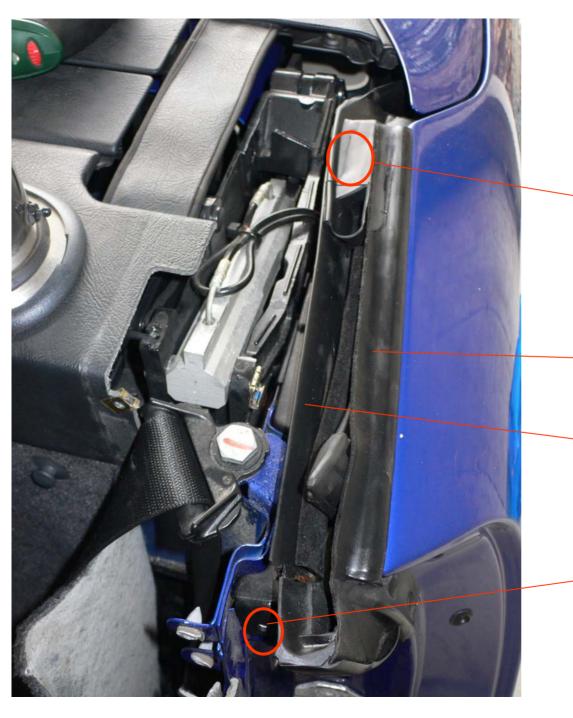
Now, Remove the rubber gasket and PVC panel by:

Lift up the rubber here. Phillips Screw below

Remove this rubber gasket

Remove PVC panel after removing screws

One phillips screw for PVC Panel here

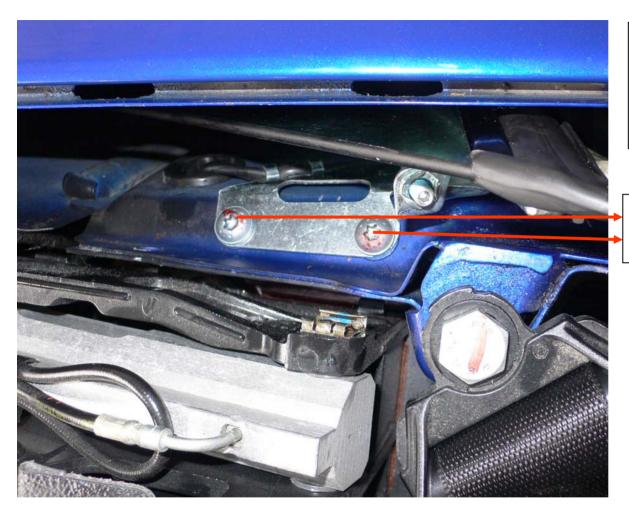
Lot more space here when gaskets are removed Removing upper window assy. bolts

Remove the upper window Assembly screws (torx)

Lower nut/bolt on the inside here. Find slot in insulation on inside.

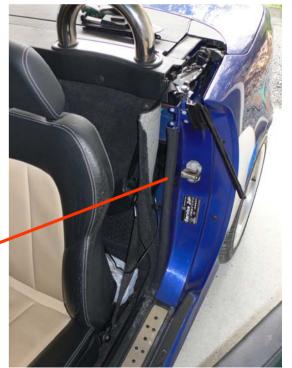
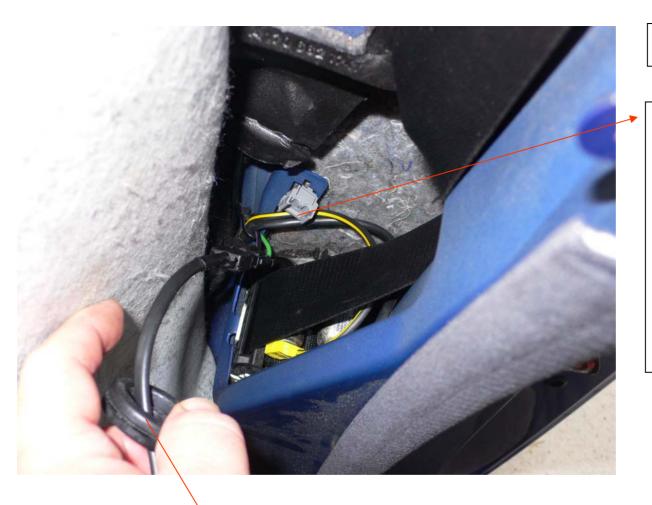
Electrical Connection

Remove electrical contact from rear wall. Disconnect and note colors.

Green towards wheel arc. Black/purple towards passenger side (for left window assy).

Pull cable and rubber gasket through hole in chassis

Whole window assy can now be removed by pulling up and tilting towards front of car. Careful – tight fit.
