Head Gasket Replacement on the M104 Engine

by Steve Brotherton
First Published in: [ImportCar](#)[∞]

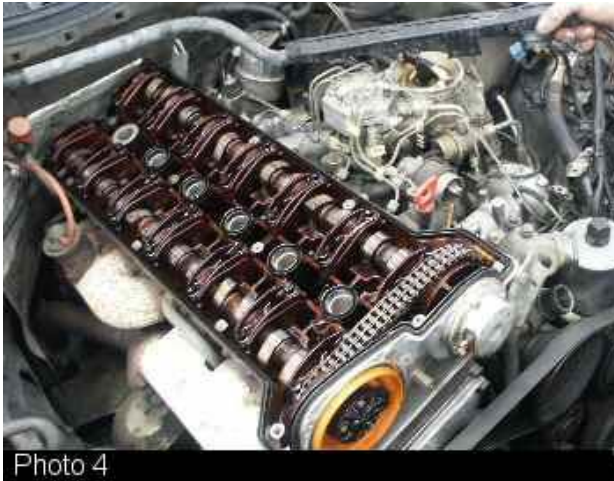
The first point of disassembly is to remove the head, intake and exhaust in one unit. So one of the first things we do is to remove the wiring harness from the intake (see Photo 4).

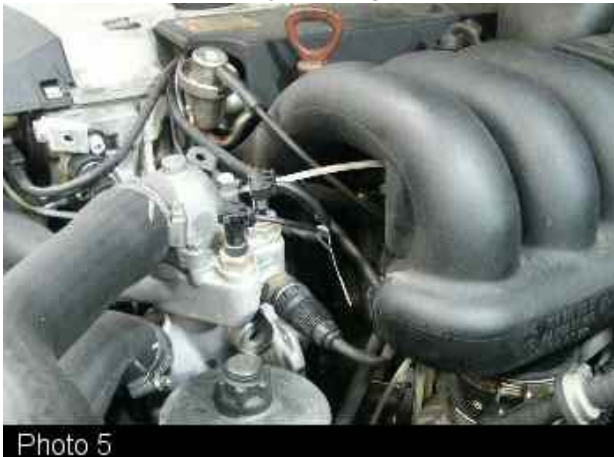
The disassembly pictures are from an early motor with an aluminum manifold and CIS-E fuel system. Most of the cars we've done have been the HFM fuel systems which have a two-part plastic/aluminum intake manifold. The two halves are connected by two large rubber hoses (see Photo 5).

We remove the head with the top/plastic manifold, separating it at those two large hoses.

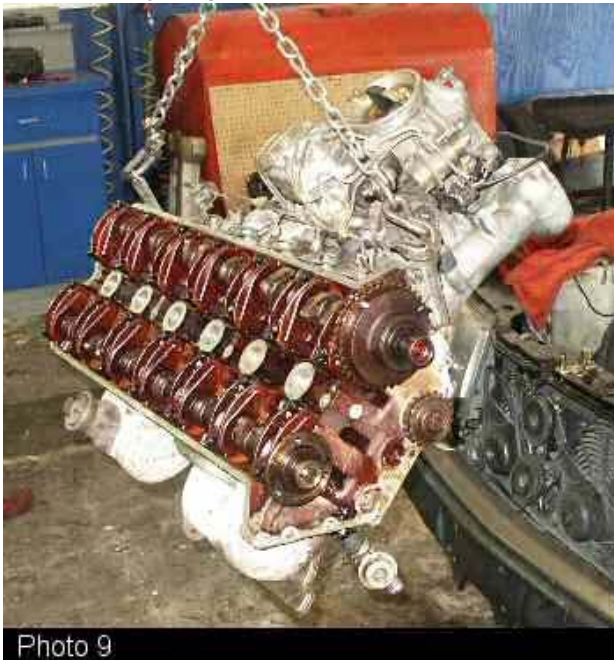
Photo 9

So with everything disconnected, we often use the engine hoist to get it all out (see Photo 9).
