A. As of approx. 09/84 to approx. 08/85

B. As of approx. 09/85 to approx. 04/86

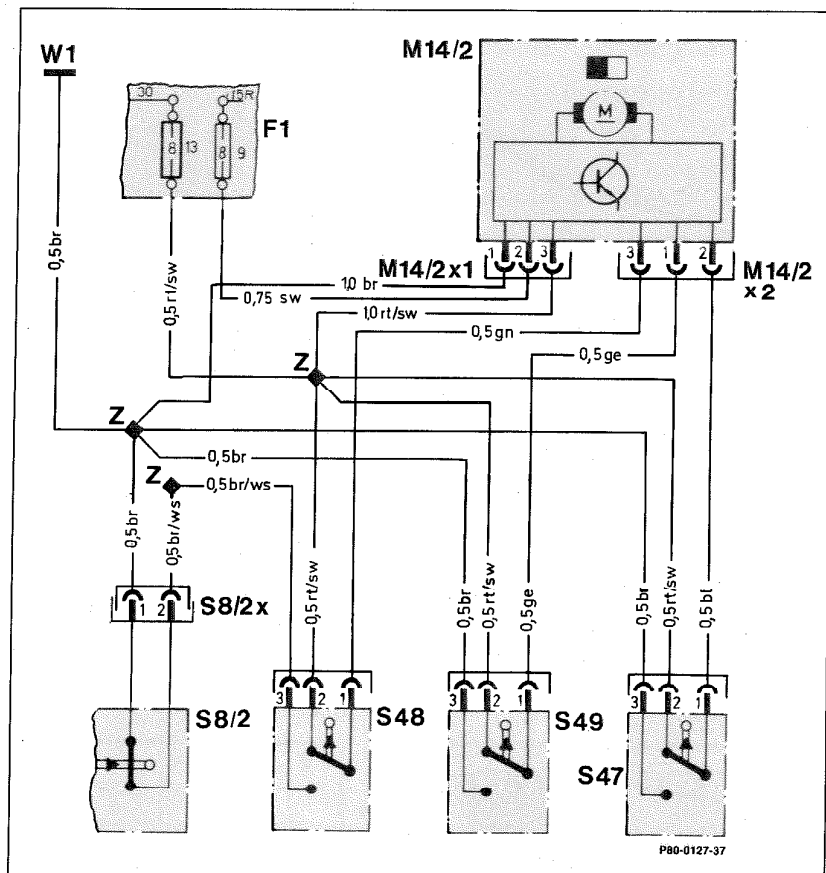
P80-0127-37

Black cable from M14/2x1 jack 2 to F1, fuse 9 is only installed with orthopedic backrest.

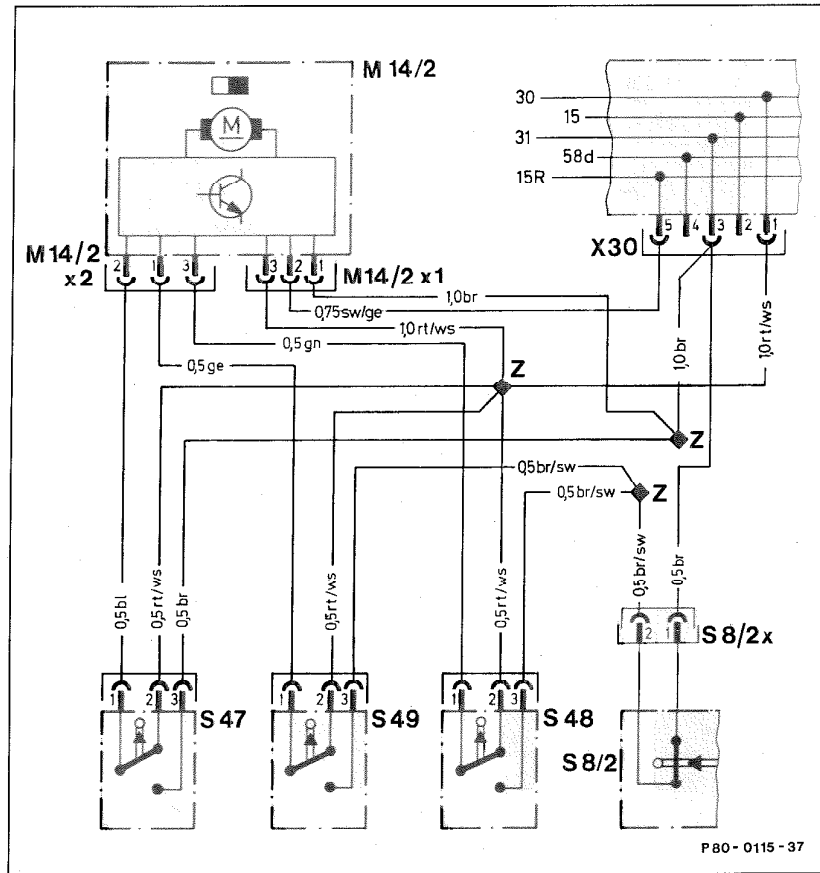
P80-0115-37

Black/yellow cable from M14/2x1 jack 2 to X30
jack 5 is only installed with orthopedic backrest.
