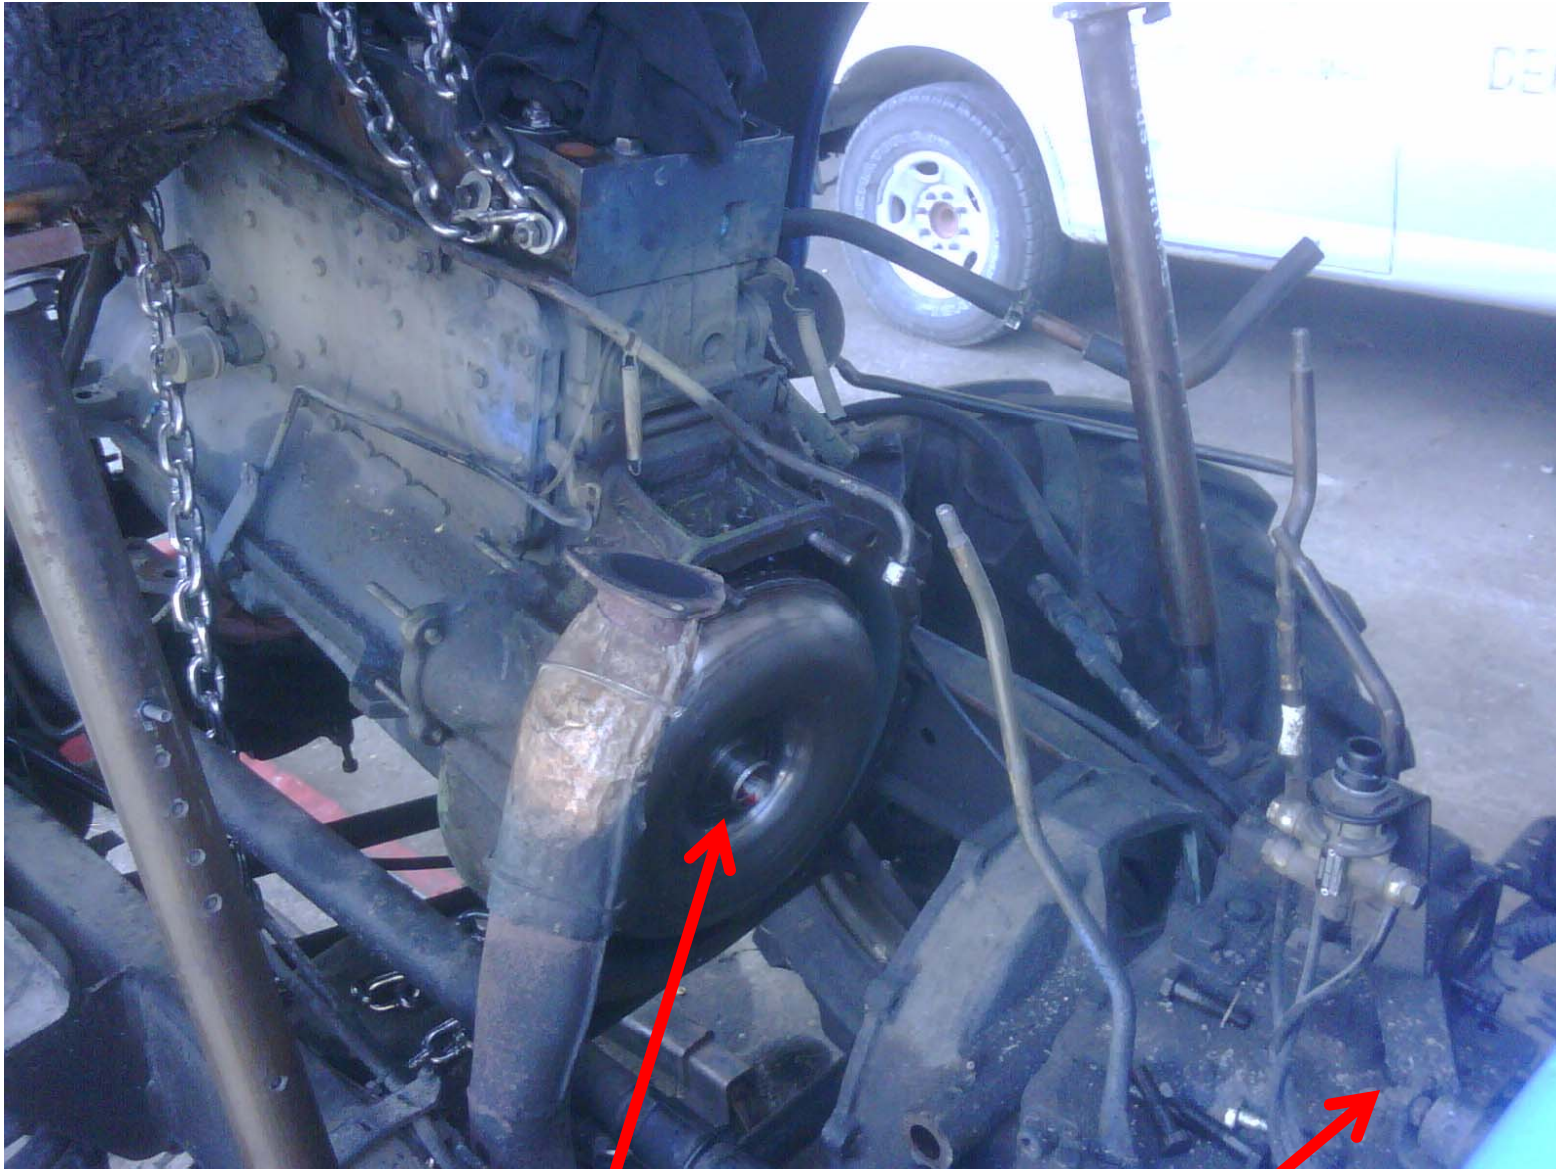
TorqueConverter

Gear Box

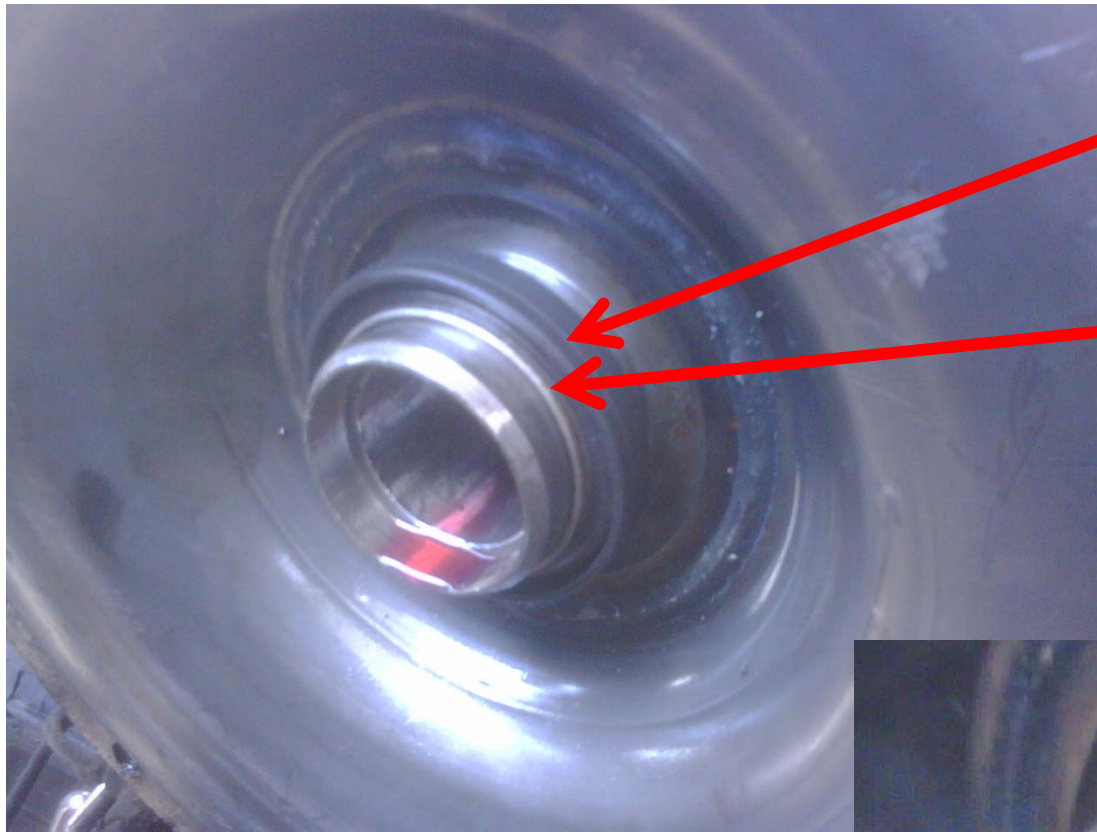
Retainer / Oring

Busing

Busing is loose , it can freely rotate. I think leak is coming from here.

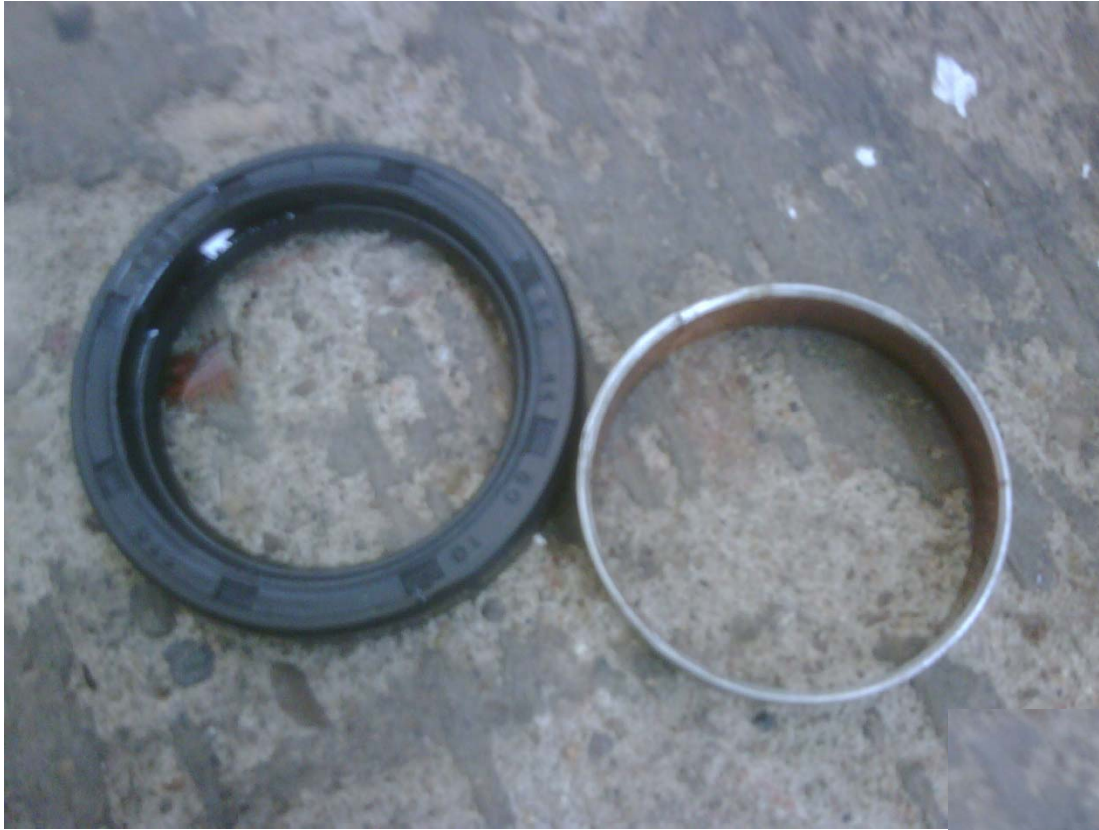
Retainer & Busing
